#PI1126F: Blank Screen After Startup and Reverse, Rear View Camera Message On, Touch Screen Inoperable, Bluetooth® and Navigation Concerns - (Jan 9, 2015)

Subject: Blank Screen After Startup and Reverse, Rearview Camera Message On, Touch Screen Inoperable, Bluetooth® and Navigation Concerns

Models: 2014 Buick LaCrosse, Regal

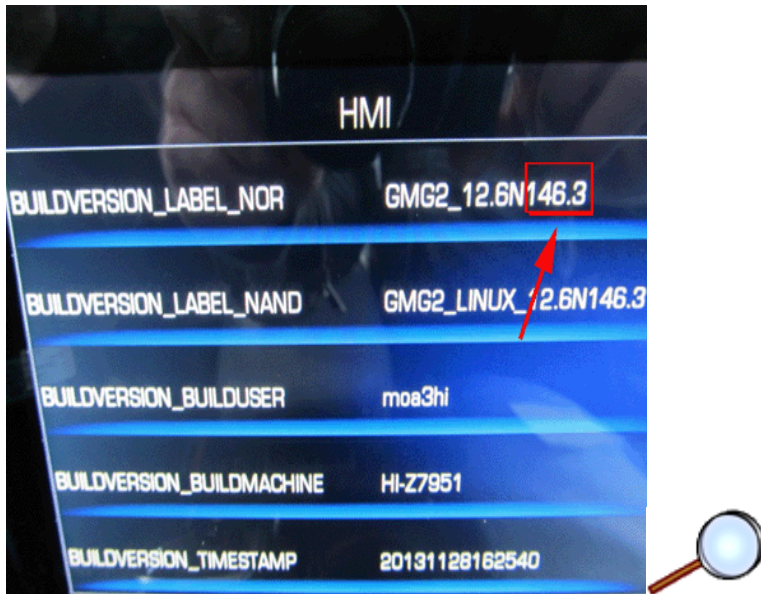
Before updating software, check the HMI build version. The HMI build version label should be GMG2.12.6N146.4 or earlier.

Caution: If the software version is GMG2.12.6N146.4 or lower, proceed with this PI. If the version is higher, damage to the HMI module may occur. DO NOT PROCEED WITH THIS PI if the version is higher.

Note: The last 3.1 numbers as shown above will increase as the software gets updated. Those are the numbers to check when verifying software version.
