BRIEF STATEMENT OF OPINIONS

Our Project No.: 216CI55

Project Name and Address: 4014 34th Street, Mount Rainier, MD

Issue(s) to be Reviewed: Roof Structure at Detached Garage Conversion

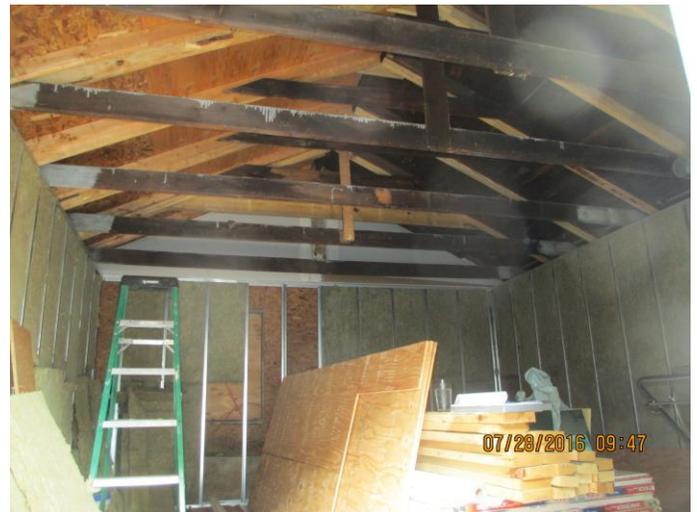
- Existing roof framing is a ridge plate and collar tie system with different size framing members at spacing's between 26 and 32 inches on center;
- Existing exterior structural walls are 2x4 construction with plywood sheathing that bear on CMU foundation walls on the left, rear and right sides (no foundation wall or foundations are assumed to be present on front wall as this was the opening for the garage door). CMU stands for Concrete Masonry Unit and is sometime referred to as cinder block colloquially.

In our discussions during the consultation you mentioned that you would like to increase the height of the ceiling in the garage in order to improve the acoustics for the planned music studio. As noted above, the current roof configuration is a ridge plate and collar tie system which means that the roof structure is only stable if there are collar ties that connect the bottom of the 'rafter' members (currently these are 2x6 members). Per best construction practices the collar tie members should be located in the bottom third of the height of the roof framing (in this case the bottom 16 inches or so) to prevent splaying of the roof under heavy loading. The addition of soundproofing will contribute to the trusting forces that cause the framing to want to splay.

Typical Existing Roof Framing

- 1) Install new collar ties at the 1/3 point of the height of the roof framing. These ties could be traditional wood framing that are nailed to the existing sloped roof members or potentially metal cables (or rods). Soundproofing the penetration of the new collar ties through the soundproofing insulation that is installed against the rafter members will be an issue because the ties will need to be connected to the sloped rafter members. We recommend speaking with your acoustics consultant to discuss if this is possible (we have made a few phone calls to date and have not been able to reach him). The advantage is that this is probably the least expensive of the options.

- 2) Install a ridge beam that will span from the front wall to the rear wall. By doing this you will eliminate the need for collar ties all together. New posts will need to be installed below the ridge beam to provide proper support and a new foundation will need to be installed below the post support in the front wall to prevent settling of the ridge beam (currently no foundations a present there). A full-length beam will be difficult to install because it will need to be long as the garage is (typically this requires cutting a hole in the front or rear wall to fit the beam). As an alternative, the new ridge beam can be shorter than that garage, but a new post and concrete footing will need to be installed in the interior space of the garage. If you don't mind losing a bit of space on the interior, this may be your best option. Engineering design of the beam and the connections to the existing members will be required. This option is probably more expensive than the first, but will allow you to have more volume in the ceiling without penetrating the soundproofing against the roof.

- 3) The third, and maybe most expensive option is to have the roof replaced in whole. This would allow you to install a prefabricated roof truss system or a ridge beam and rafter system. The advantages are that you can construct the roof in a stronger manner and you can ensure that the connections to the exterior walls meet the building code requirements (currently the rafter to wall connections are sub-par). Surprisingly, this option may be in the same ballpark for cost as Option Two because the demolition and installation of trusses should be fairly quick, whereas the installation of a ridge beam in the space may require more labor and time.
