Summary Only

Property Address:
4106 Moxie Way
Lot 7.512
Charlotte NC 28215

General Summary

A. Crawl Space/ Slab Foundation Findings

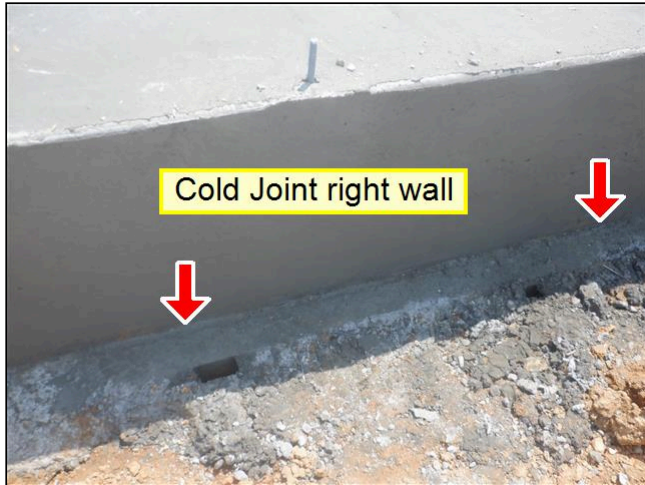
A. Item 1(Picture)

- The right wall is over 2 feet tall and appears to have been poured with a cold joint on top of a footing. With this height wall there is usually a stem wall poured with minimum of #4 rebar supporting this both horizontal and vertical. I was not able to view any steel reinforcement before the pour was made. A structural engineer is needed to design and verify the wall for stability. The wall is bowed out at this time at the bottom area. (See Photo)
