**6F50/6F55 TRANSMISSION—SLUGGISH
ACCELERATION FROM 0-8 KM/H (0-5 MPH)
FOLLOWED BY A HARSH BUMP OR A SLIP ON
TAKE-OFF FOLLOWED BY A BUMP—BUILT ON OR
BEFORE 4/15/2011**

TSB 11-12-10

This article supersedes TSB 11-9-11 to update the Service Procedure.

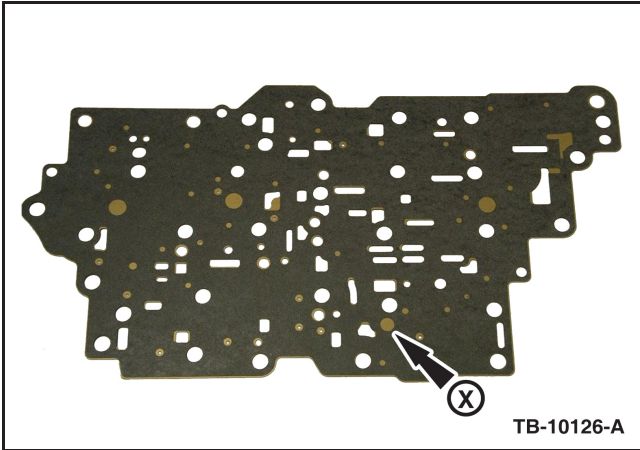
Figure 1 - Article 11-12-10

1. For all model years except 2009, proceed to Step 2. For 2009 model year vehicles, verify the transmission dipstick has MERCON® LV listed on the dipstick.
 - a. Yes - The dipstick has MERCON® LV listed on the dipstick; proceed to Step 2.
 - b. No - The dipstick does not have MERCON® LV listed on the dipstick; this procedure does not apply. Follow normal Workshop Manual diagnostics.
2. Reprogram the PCM to the latest calibration using IDS release 73.04 and higher. This new calibration is not included in the VCM 2011.5 DVD. Calibration files may also be obtained at www.motorcraft.com.
3. Remove the transmission valve body. Refer to the Workshop Manual (WSM), Section 307-01.
4. Replace both separator plates listed in the Parts List. The X identifies the hole in the valve body separator plate which will be eliminated. (Figure 1)

There is a new calibration and transmission valve body change to correct this condition. The valve body change was to delete one hole in the valve body separator plate and remove one check ball from the valve body in the same area where the hole in the separator plate was deleted.

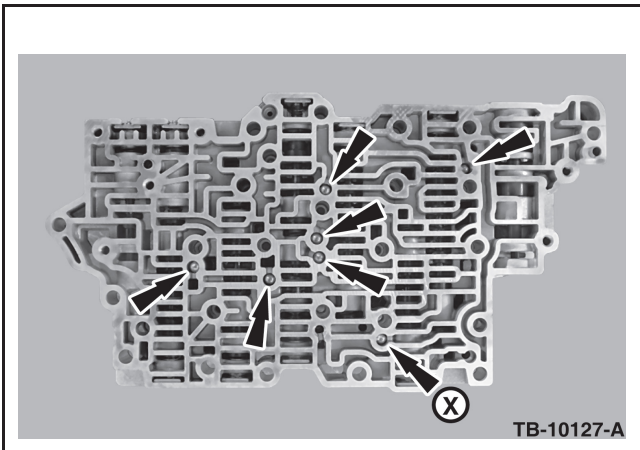
Figure 2 - Article 11-12-10

5. Remove one (1) check ball identified as X. (Figure 2)

- a. Proper check ball locations on the remaining six (6) valve body check balls shown with arrows. (Figure 2)
6. Install transmission valve body. Refer to WSM, Section 307-01.
