TECHNICAL BULLETIN

No: LTB00310 (ISSUE 2)
20 SEPTEMBER 2010

RANGE ROVER

Air Suspension System - New Height Sensor Availability

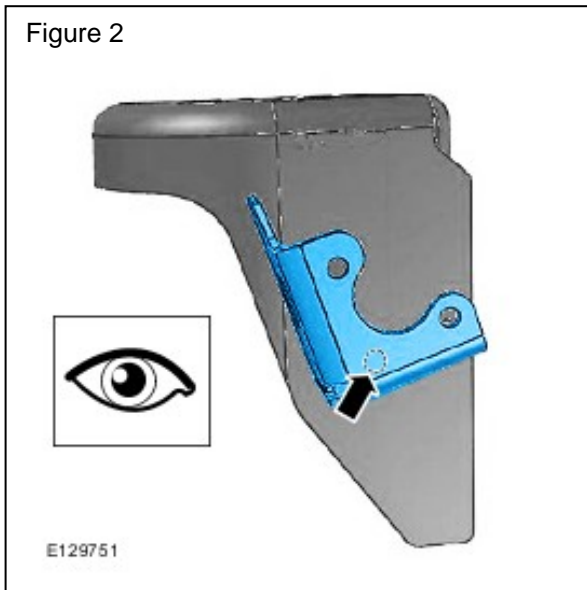
CAUTION: The bracket shown in Figure 2 may have two or three holes. It is important that the orientation of the bracket is noted and not the number of holes.

- If the orientation of the left-hand rear (LHR) ride height sensor bracket is the same as Figure 2, continue to step 3.
- If the orientation of the LHR ride height sensor bracket is not the same as Figure 2, continue to step 2.
- If the ride height sensor bracket is installed as shown in Figure 3, continue to step 2.

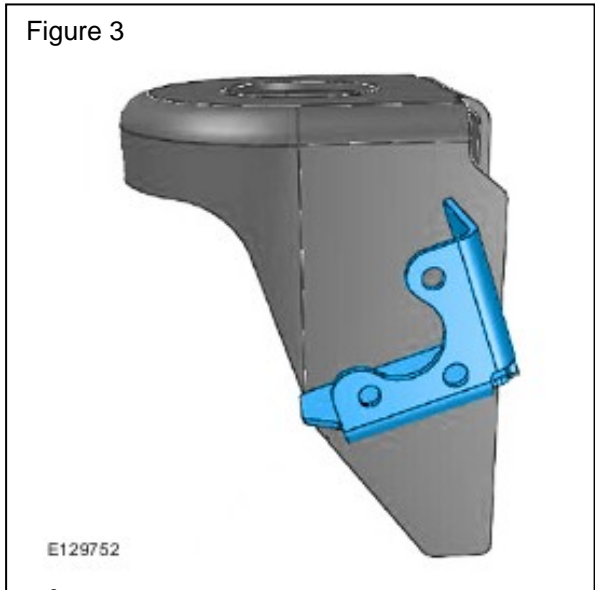
Figure 3

NOTE: This condition affects only a small number of chassis frames of vehicles built at the end of 2009.
