STAR Case

Case Number: S1208000174

No Start Or Slow Start When Cold, Click No Start

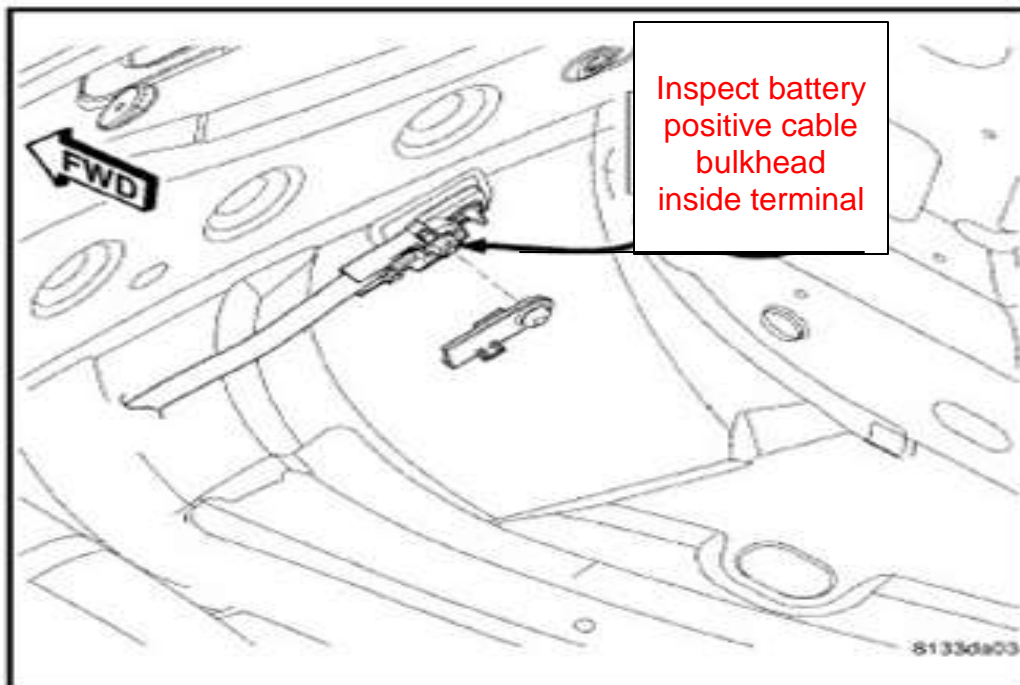
No start or click no start complaints; may have MIL lamp and or battery lamp on. Some recent reports indicate that the B+ battery cable connections from battery to the front TIPM may create this condition.

Inspect for poor connections or dirty battery cables from the rear battery to the front TIPM. The B+ battery cable has an interior bulkhead terminal connection. This connection point is located under the front passenger carpet. Some reports have located this connection point as the area of concern. Clean and or replace this terminal as needed.
