## STAR Case

**Case Number:** S1309000016

**Symptom/Vehicle Issue:** Ticking/Tapping Noise From Upper Engine Area

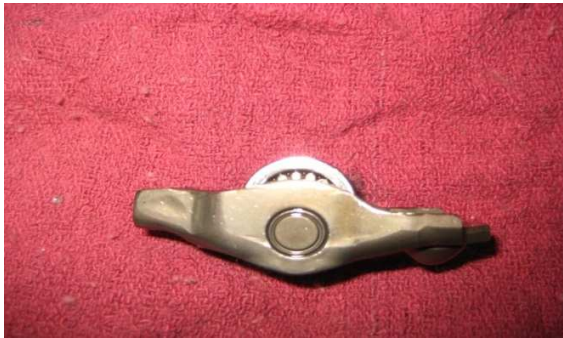
(Fig.1)

**Diagnosis:** Remove components required to gain access for proper inspection of each rocker arm roller bearing for missing or worn needle bearings (**Fig.1** & **Fig.2**). Also inspect for collapsed lash adjusters (**Fig.3**) and replace as required. Please note that this condition is typically found on vehicles with mileage accumulation of 15K miles or more.

Replace all rocker arms with latest superseded part.
