# Service Bulletin

Bulletin No.: 02-06-04-024D

**Subject:** Service Engine Soon (SES)/Check Engine Light MIL Illuminated, Secondary Air Injection Reaction (AIR) Pump Ingesting Water and DTC P0410 Set (Replace Secondary AIR Pump and Inlet Hose Assembly)

**Models:** 2000-2004 Cadillac DeVille  
Built Prior To March 30, 2004  
2001-2004 Cadillac Seville  
2001-2003 Oldsmobile Aurora

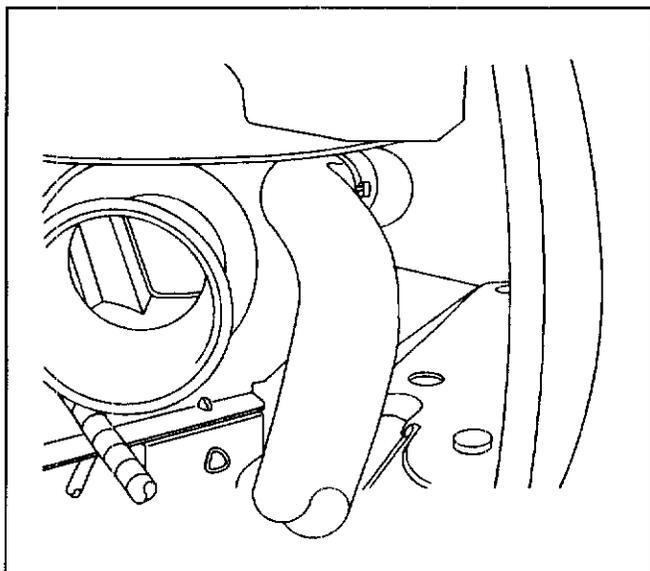
1594244

**Important:** Located on the inner fender behind the air box there is a oval stamped hole. The new AIR filter must snap into this hole in order for the AIR pump to avoid ingesting water.

12. Route the new AIR pump inlet hose between the left inner and out fenders as shown above.

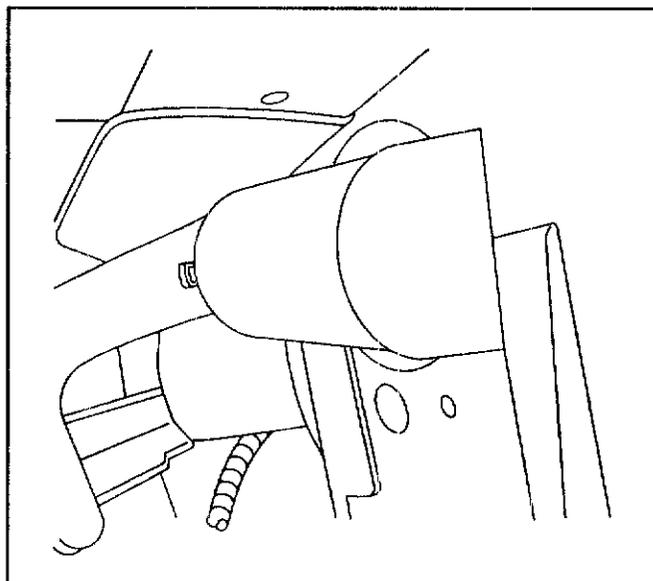
1594245

**Notice:** Secure the new AIR pump inlet hose filter into the opening on the inner fender as shown above. Failure to secure the filter in the inner fender as shown below may result in a repeat pump failure.

13. Snap the filter into the inner fender opening as shown above.
14. Reposition the inner fender splash shield into position.
15. Install the inner fender splash shield retainers.
16. Lower the vehicle
17. Install the left headlamp assembly. Refer to:
  - Aurora — Headlamp Replacement, SI Document ID# 637921.
  - DeVille — Headlamp Replacement, SI Document ID# 462164.
18. On DeVille models, install the upper filler panel. Refer to SI Document ID# 477645.
19. Remove the fender covers and close the hood.
20. With a scan tool clear the DTC's and road test the vehicle.

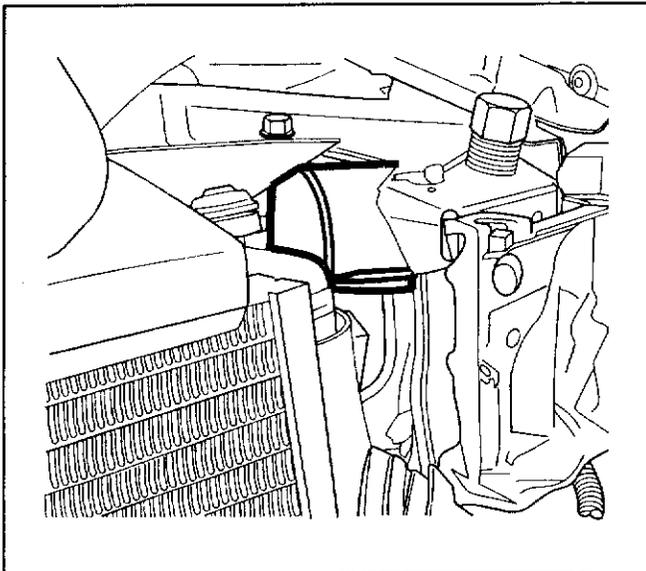
1630804

**Notice:** It is critical that the new AIR inlet hose filter opening is facing downward when installed on the vehicle. Failure to mount the opening facing downward may result the AIR pump ingesting water, causing pump failure.

10. Secure the new AIR hose filter with a plastic tie strap to the upper radiator support with the filter opening facing downward as shown above.
11. Reinstall the headlamp assembly. Refer to:
  - Headlamp Replacement (SLS, w/o TT6, TT7 or TT8), SI Document ID# 692955.
  - Headlamp Replacement (SLS and STS w/TT6, TT7 or TT8), SI Document ID# 773808.
12. Reinstall the upper filler panel. Refer to Filler Panel Replacement - Upper in Body Front End (SI Document ID# 540569).
13. Use a scan tool clear the DTCs and road test the vehicle.
