# Ultra Cheap Way of W210 Evaporator Temperature Sensor Repair

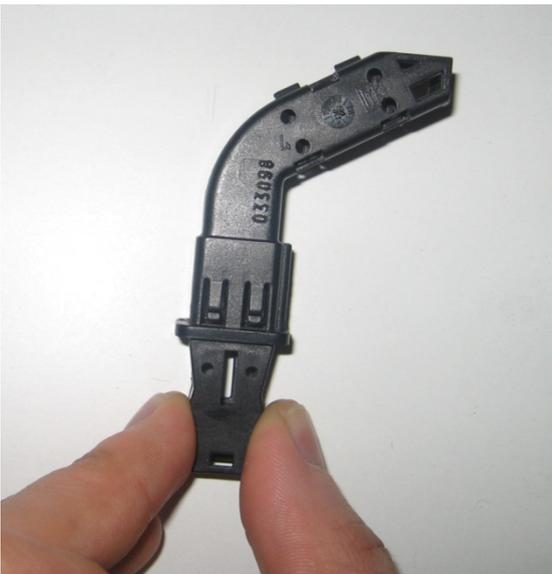
Here is the sensor:

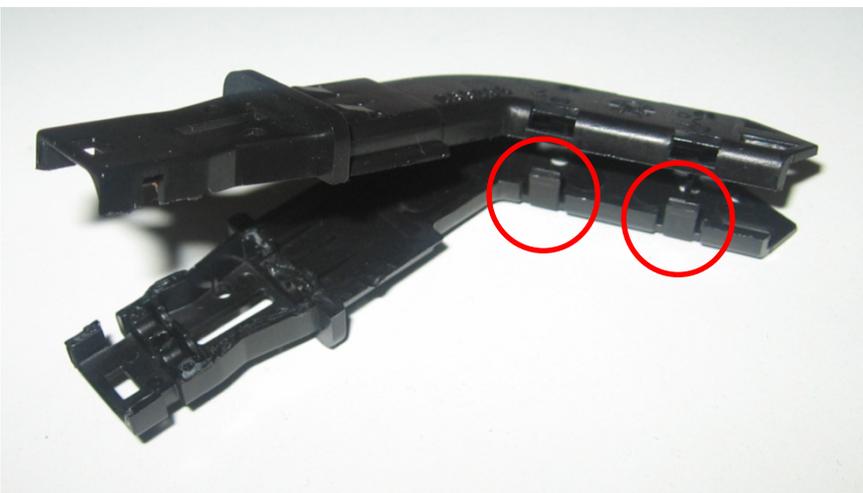
There are two notches in front part of the sensor (you can see them in red circles on the following picture) you have to release them first, but the rear part is glued. You need to separate two halves of the sensor by cracking glue with the aid of a knife/flat head screwdriver etc.

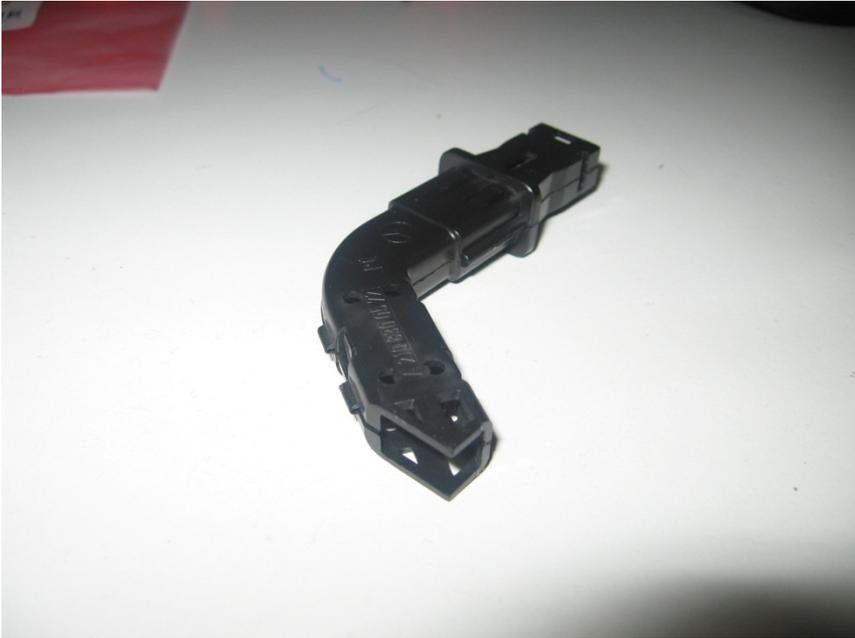
Put few drops of cyanoacrylate adhesive (Pattex etc.) to the originally glued part of the sensor and close the halves. Keep squeezing the back side for few minutes to guarantee the adhesion. After then, your sensor is ready for installation.
