# 10-06-01-008M: Engine Oil Consumption on Aluminum Block/Iron Block Engines with Active Fuel Management (AFM) (Install AFM Oil Deflector and Clean Carbon from Cylinder and/or Install Updated Valve Cover) - (Nov 26, 2014)

Subject: Engine Oil Consumption on Aluminum Block/Iron Block Engines with Active Fuel Management (AFM) (Install AFM Oil Deflector and Clean Carbon from Cylinder and/or Install Updated Valve Cover)

Models: 2007-2014 Cadillac Escalade Models  
2007-2013 Chevrolet Avalanche, Silverado  
2007-2014 Chevrolet Suburban, Tahoe  
2010-2012 Chevrolet Colorado  
2010-2015 Chevrolet Camaro  
2007-2013 GMC Sierra, Sierra Denali  
2007-2014 GMC Yukon Models  
2010-2012 GMC Canyon  
2008-2009 Pontiac G8 GT  
Vehicles Built Prior to February 1, 2011 Require Updated Valve Cover and October 2010 Require AFM Shield  
Equipped with Any of the Following Engines:  
- Aluminum Block V8 Engine with Active Fuel Management (AFM) (RPOs LH9, L94, LZ1, L99, LC9, LH6, L76, L92, LFA (Hybrid))  
- Iron Block V8 Engine with Active Fuel Management (AFM) (RPOs LMG, LY5)

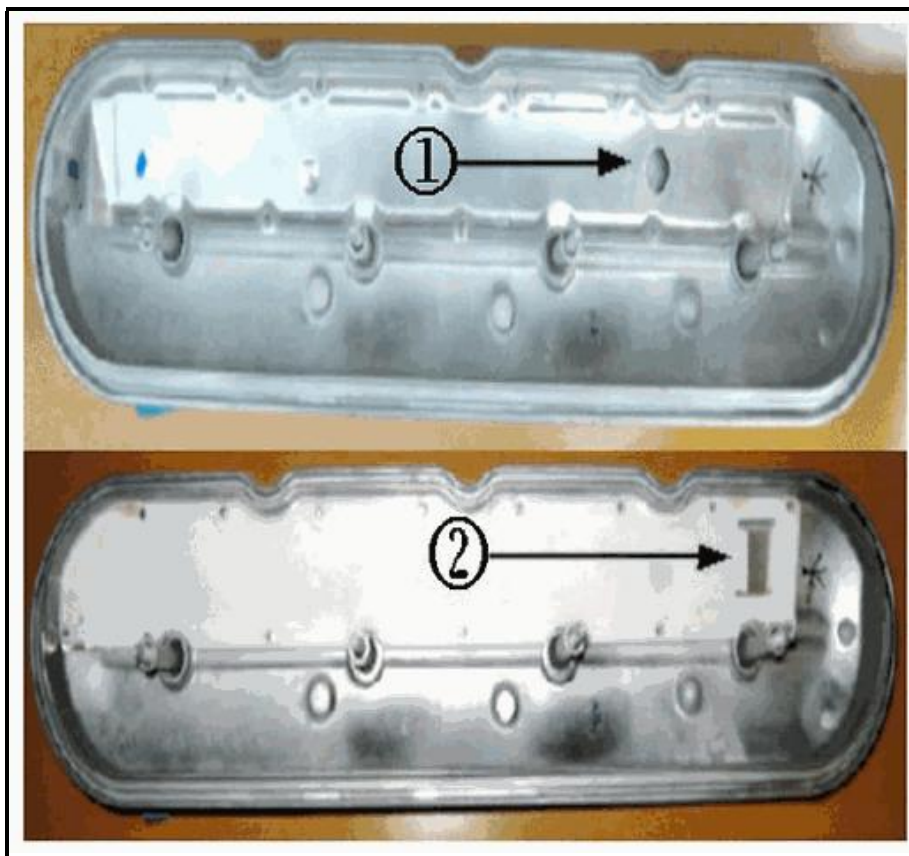
1) Old Design

2) New Design

PCV pullover or an overactive lifter can cause oil to be pulled through the PCV system even at low vehicle mileage. A correctly functioning PCV system will only leave a film of oil in the intake manifold. Inspect the intake manifold to see if there is any oil puddling in the bottom. If there is you will need to replace the left valve cover. Two new left rocker arm covers have been released for trucks and vans. Technicians should replace the left rocker arm cover with GMP/N 12570427 for 2007-2008 or GMP/N 12642655 for 2009-2011. Refer to the Parts Information below for the Camaro. This rocker arm cover has a relocated PCV drain hole that prevents oil from entering the intake manifold. Refer to Valve Rocker Arm Cover Replacement - Left Side in SI.

When installing the updated valve cover or reinstalling a used valve cover, verify that the baffles can hold water and do not leak. If any leaks are found, seal with RTV if possible or replace the valve cover. Thoroughly clean and dry the valve cover before installation.

These rocker covers are for specific years. The PCV orifice is different for each. The correct cover must be used or an SES light may set.

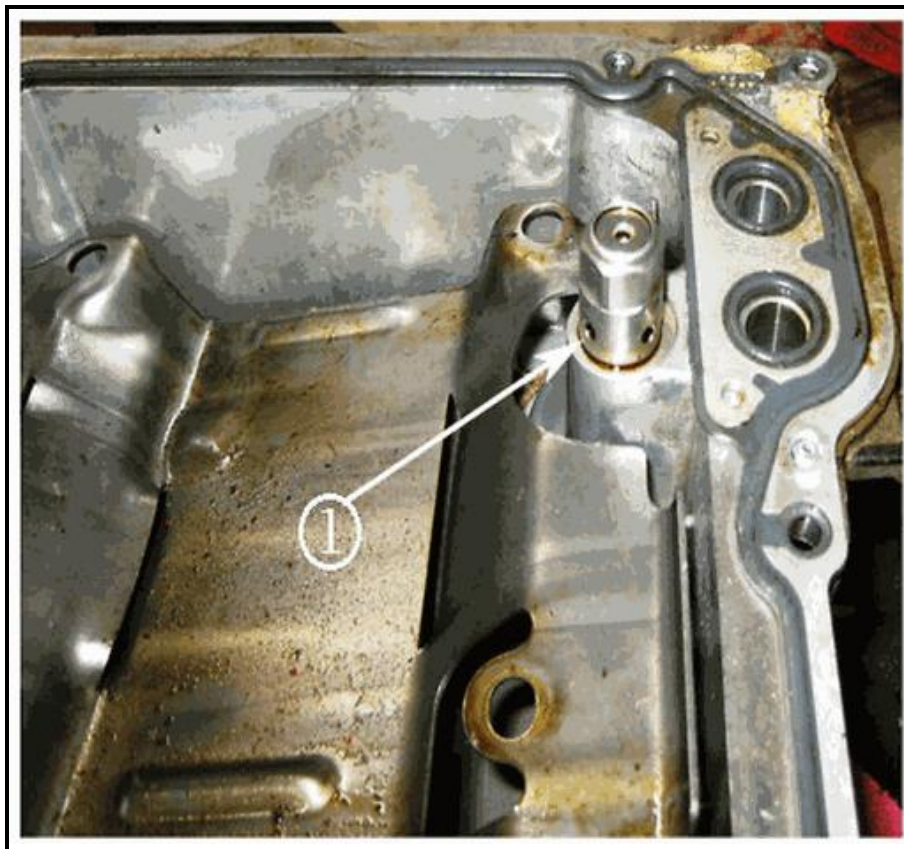
4. Remove the AFM valve (1).

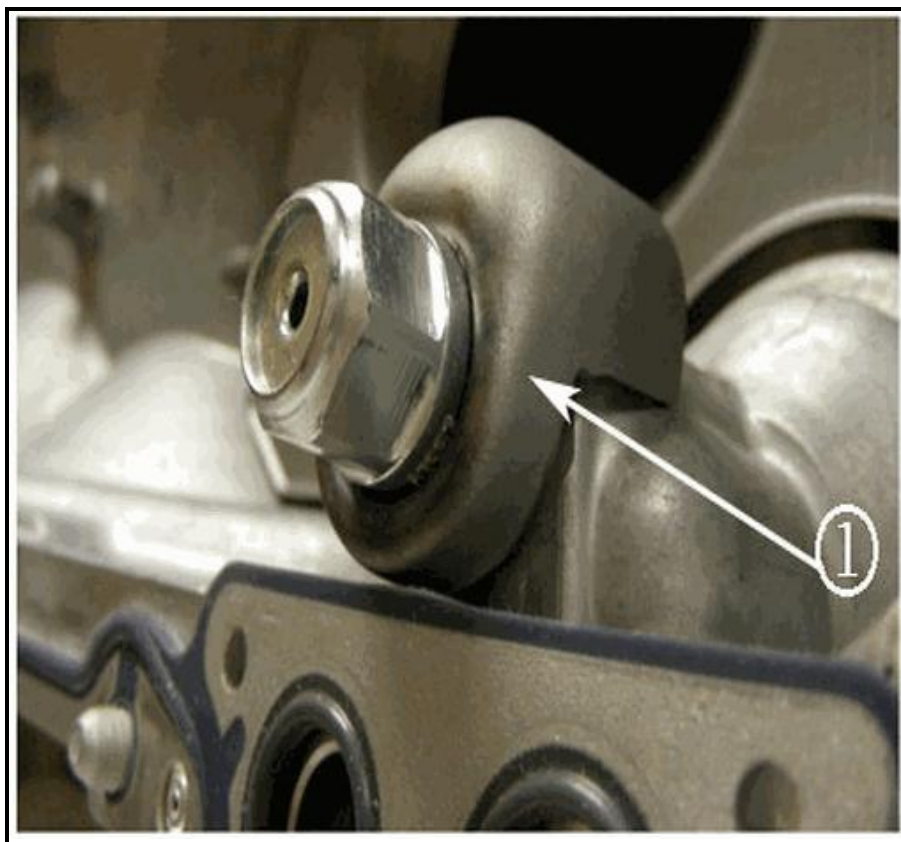
5. Install the new shield (1), GMP/N 12639759, and tighten the AFM valve to the oil pan to 28 N.m (20 lb ft).
