Fault Code 3251

Aftertreatment 1 Diesel Oxidation Catalyst Intake Temperature - Data Valid But Above Normal Operating Range - Moderately Severe Level

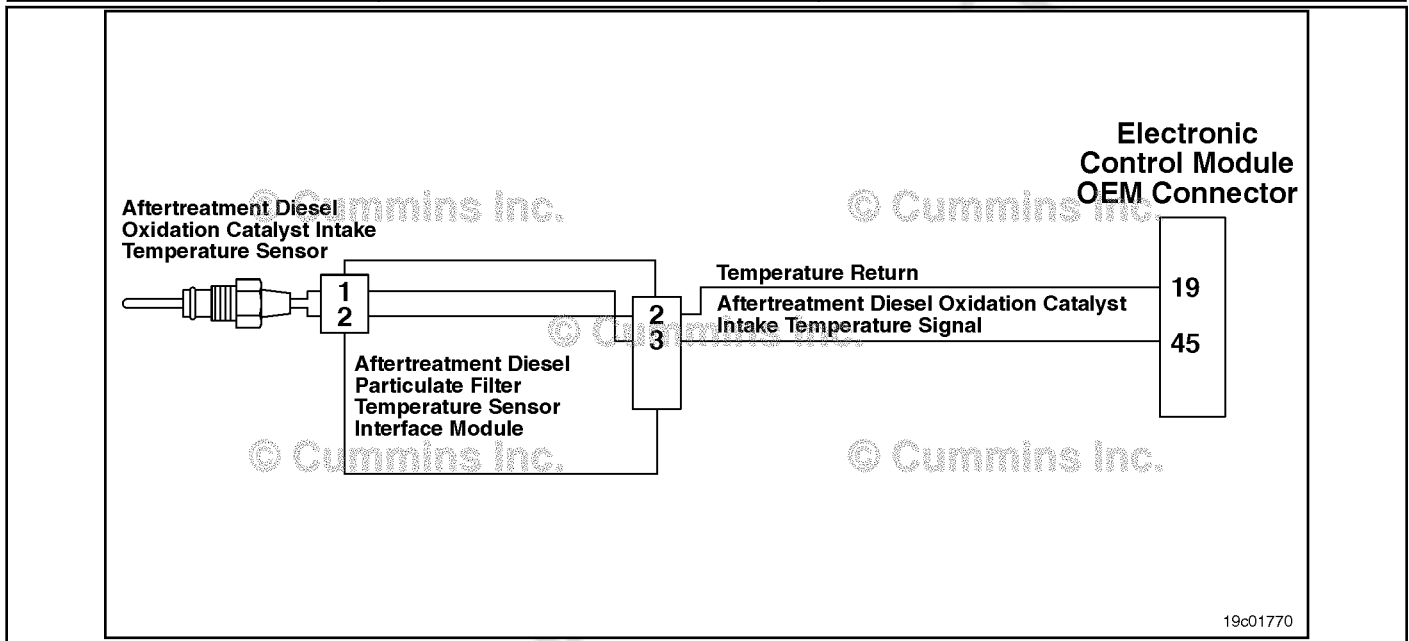
Aftertreatment Diesel Particulate Filter Temperature Sensor Module

Circuit Description:

The aftertreatment temperature sensors are used by the engine control module (ECM) to monitor the engine exhaust temperatures in the aftertreatment system. The aftertreatment temperature sensors are thermistors and change resistance based on the temperature being measured. The ECM provides a 5 volt reference voltage to the sensor. The ECM monitors the change in signal voltage and converts this to a temperature value.

When the exhaust temperature is cold, the sensor or thermistor resistance is high. The ECM signal voltage **only** pulls down a small amount through the sensor to ground. Therefore, the ECM senses a high signal voltage or low temperature. When the exhaust gas temperature is hot, the sensor resistance is low. The signal voltage pulls down a large amount. Therefore, the ECM senses a low signal voltage, or a high temperature.
