## General Information

The following procedure contains troubleshooting steps and information regarding the aftertreatment system.

**Note :** The information in this procedure only applies to rear gear train engines.

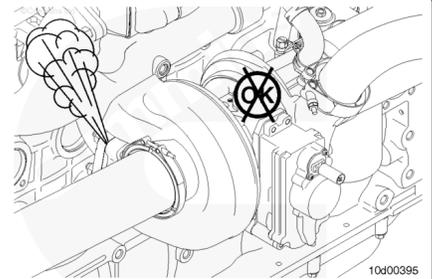
Leaks in the exhaust system can cause exhaust odor or white smoke.

Inspect the exhaust piping for leaks, cracks, and loose connections. Refer to Procedure 010-024 in Section 10. (</qs3/pubsys2/xml/en/procedures/31/31-010-024-tr-isb10.html>)

Tighten the exhaust clamps, if necessary. See equipment manufacturer service information for the correct torque value.

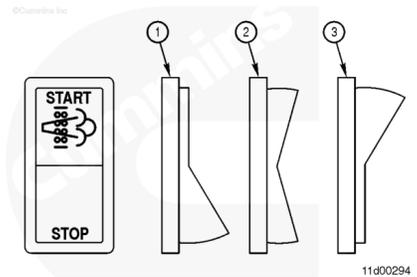
The permit switch can be hardwired to the ECM, or it can be multiplexed over J1939 multiplexing.

A J1939-multiplexed permit switch signal has priority over a hardwired start switch signal, so if the permit switch is enabled over J1939, the hardwired signal is ignored by the engine ECM.

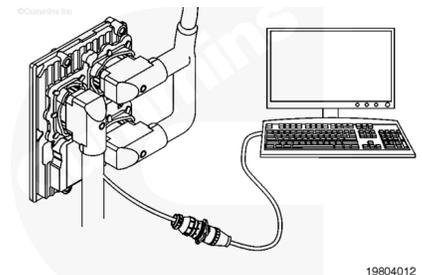
19804012

Unplug each of the aftertreatment exhaust gas temperature sensors, one at a time.

If the voltage changes when the sensor is unplugged, the wiring harness connector is connected to the correct sensor.

If the voltage does **not** change when the sensor is unplugged, switch the connector location to the other temperature sensor, unplug it, and check for a voltage change.

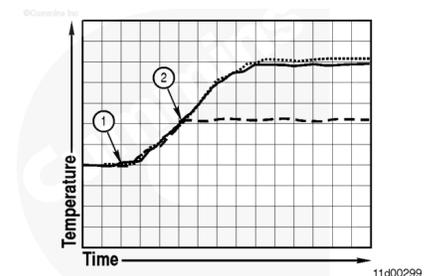
A normal stationary (parked) regeneration will follow the pattern shown.

- The dashed line is for the aftertreatment DOC inlet temperature sensor
- The dotted line is for the aftertreatment DPF inlet temperature sensor
- The solid line is for the aftertreatment DPF outlet temperature sensor.

When the stationary (parked) regeneration begins (1), all three temperatures should be approximately the same, and should increase at the same rate.

The wiring to the aftertreatment temperature sensors appears to be correct in this example, because they all read approximately the same temperature at the beginning of the stationary (parked) regeneration and increase at the same rate.

Aftertreatment injection begins when all three temperatures reach approximately 289°C [552°F] (2).

Once aftertreatment injection begins, the aftertreatment DOC inlet temperature may vary slightly, but will typically remain between 260 and 399°C [500 and 750°F].

The aftertreatment DPF inlet and outlet temperatures will increase to approximately 482 to 649°C [900 to 1200°F]. The temperatures may vary during the stationary (parked) regeneration, as the amount of fuel injected during aftertreatment injection is changed to maintain a constant temperature.

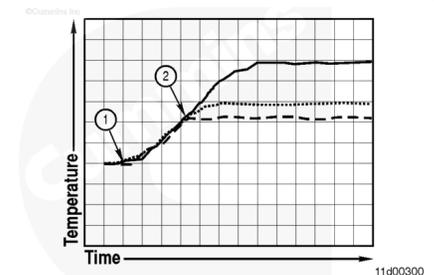
This graph illustrates a stationary (parked) regeneration where the inlet of the aftertreatment DOC is blocked.

In this condition, the engine speed will increase to the stationary (parked) regeneration speed of 1000 to 1100 rpm.

Raising the aftertreatment temperature to the aftertreatment injection temperature may take longer to complete than normal if the inlet to the aftertreatment DOC is plugged, restricting some of the exhaust flow.

Once aftertreatment injection begins (2), the aftertreatment DPF inlet and outlet temperatures will differ greatly due to the plugged aftertreatment DOC being unable to oxidize the injected fuel. The aftertreatment DPF has some capability to oxidize the injected fuel, but can **not** maintain this condition

without damaging the filter material over time. It is possible that white smoke would be present from the vehicle tailpipe in this condition.

The wiring to the aftertreatment temperature sensors appears to be correct in this example, because they all read approximately the same temperature at the beginning of the stationary (parked) regeneration and they increase at the same rate.

The possible cause of this condition is a plugged aftertreatment DOC. Use the following procedure to inspect the aftertreatment DOC. Refer to Procedure 011-049 in Section 11. (</qs3/pubsys2/xml/en/procedures/31/31-011-049-tr-isb10.html>)

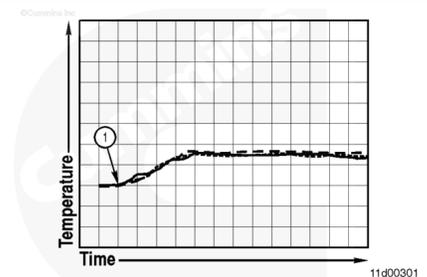
This graph illustrates a stationary (parked) regeneration where the engine can **not** build enough heat to start aftertreatment injection (1).

- The dashed line is for the aftertreatment DOC inlet temperature sensor
- The dotted line is for the aftertreatment DPF inlet temperature sensor
- The solid line is for the aftertreatment DPF outlet temperature sensor.

The engine speed will likely increase to the stationary (parked) regeneration speed of 1000 to 1100 rpm, but because the aftertreatment temperatures do **not** increase enough to start aftertreatment injection, the stationary (parked) regeneration will **not** complete.

The wiring to the aftertreatment temperature sensor appears to be correct in this example, because they all read approximately the same temperature for the same conditions.

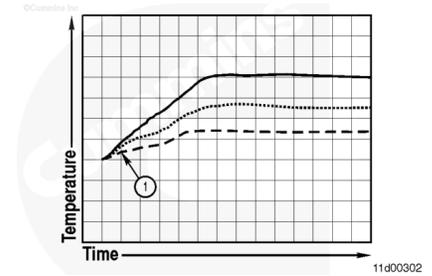
This graph illustrates a stationary (parked) regeneration where the wiring to the aftertreatment temperature sensors is incorrect (1).

- The dashed line is for the aftertreatment DOC inlet temperature sensor
- The dotted line is for the aftertreatment DPF inlet temperature sensor
- The solid line is for the aftertreatment DPF outlet temperature sensor.

In this condition, the engine speed will increase to the stationary (parked) regeneration speed of 1000 to 1100 revolutions per minute (rpm).

Aftertreatment injection will **not** occur in this condition because the aftertreatment DOC inlet temperature does **not** reach the required temperature. Because aftertreatment injection is **not** occurring, the aftertreatment temperatures should **not** read differently.

The possible cause of this condition is an incorrectly assembled aftertreatment wiring harness. See the aftertreatment exhaust gas temperature sensor wiring information in this procedure.

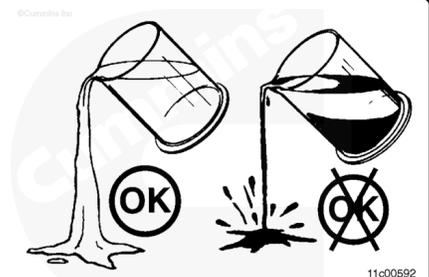
DEF is comprised largely of water. Petroleum based liquids will separate from the DEF and rise to the top. Check for separation of the fluids, as well as their characteristics.

If contaminated, reference the steps detailed later in this procedure.

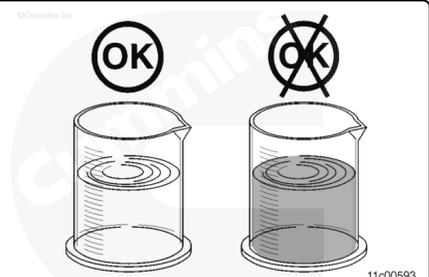
Inspect for non-petroleum base liquids, such as, but not limited to:

- Water
- Coolant
- Windshield washer fluid.

If water has been added, the DEF will remain clear. As a result, the DEF will become diluted, reducing the concentration level.
