Applies To: **2003–08 Civic Hybrid** – Check the iN VIN status for eligibility

### Warranty Extension: IMA Battery Module

(Supersedes 12-077, dated December 21, 2012, to revise the information marked by the black bars)

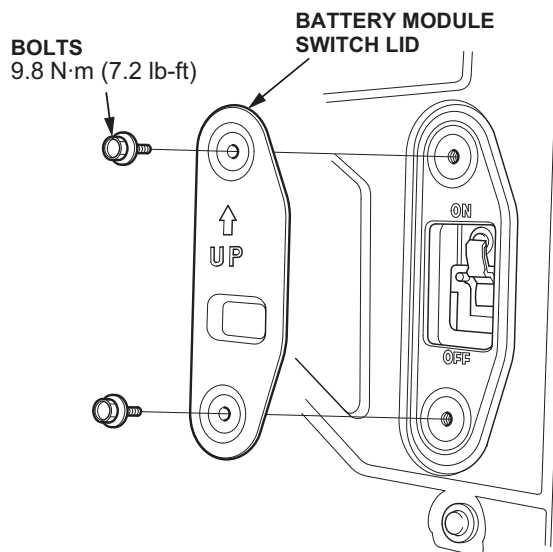
### 2006-08 Shown (2003-05 similar)

1. Make sure the ignition switch is in LOCK (0).
2. Do the battery terminal disconnection procedure.
3. Remove the rear seat-back and the rear seat cushion.
4. Remove the battery module switch lid.

14. Reinstall the battery module switch lid.
15. Reinstall the seat-back and the rear seat cushion.
16. Do the battery terminal reconnection procedure.
17. Update the BCM software. Refer to Service Bulletin 10-083, *IMA Battery Software And Hardware Updates*.
18. Charge the new battery by starting the engine, and maintaining 3500 to 4000 RPM in park until the IMA battery charge display shows that the IMA battery has 4 bars of charge.

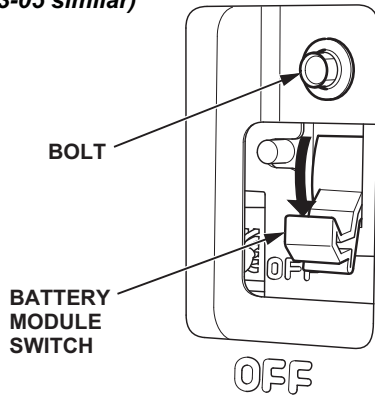
**2006-08 Shown  
(2003-05 similar)**

- Turn the battery module switch OFF.

13. Turn the battery module switch ON.

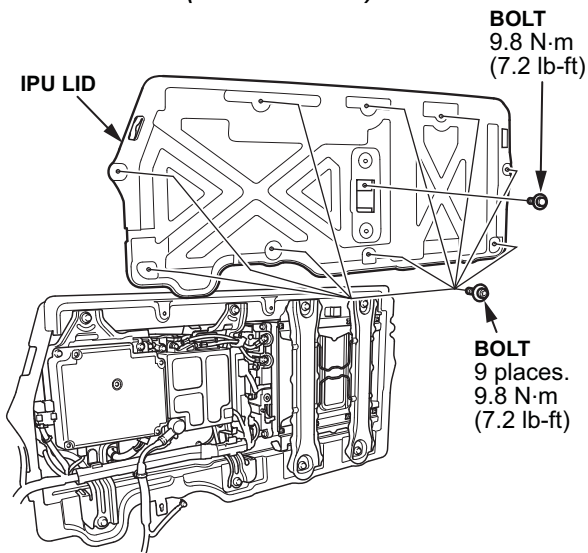
**2006-08 Shown (2003-05 similar)**

- Remove the IPU lid.

12. Reinstall the IPU lid.

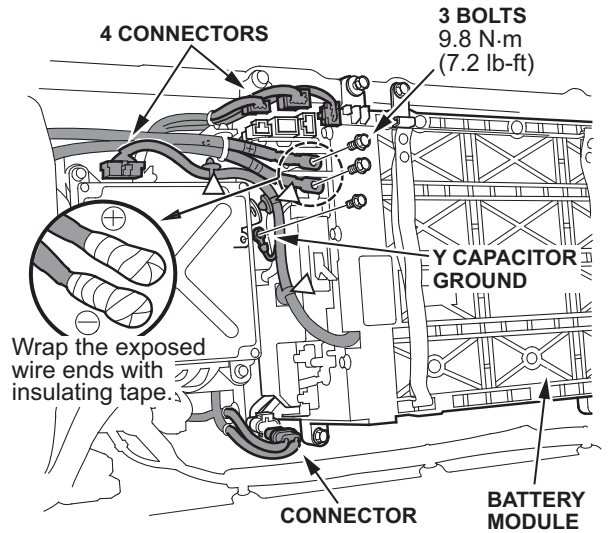
**Disconnect the module harnesses:**

- 2003–05 Models: Remove the battery module.
  - Disconnect the connectors, the Y capacitor ground, and the high voltage cables, and wrap the cables with insulating tape.
  - Disconnect the clips.
  - Remove the battery bracket.
  - Remove the four bolts.

10. 2003–05 Models: Install the battery module.
  - Reinstall the four bolts and torque them to **24 N•m (17 lb-ft)**.
  - Reinstall the battery bracket.
  - Reconnect the Y capacitor ground.
  - Reconnect the connectors.
  - Reconnect the high voltage cables and torque the bolts to **9.8 N•m (7.2 lb-ft)**.
  - Reconnect the clips.
11. 2006–08 Models: Install the battery module.
  - Reinstall the four bolts and torque them to **22 N•m (17 lb-ft)**.
  - Reconnect the BCM module connector and the junction board connector.
  - Reconnect the high voltage cables.

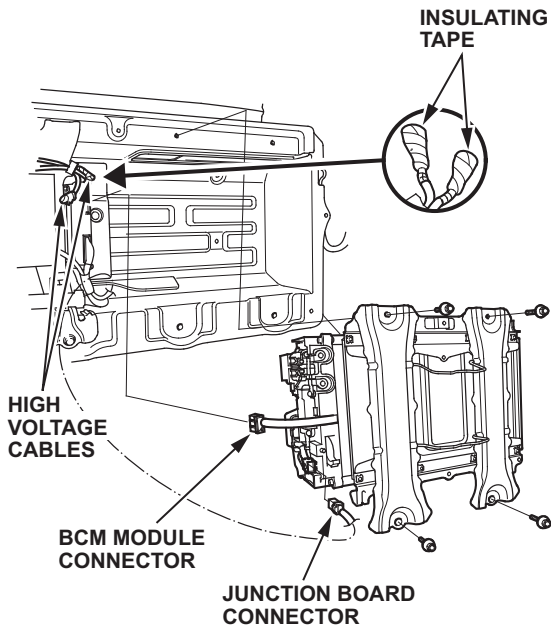
8. 2006–08 Models: Remove the battery module.
  - Remove the high voltage cables and wrap them with insulating tape.
  - Disconnect the BCM module connector and the junction board connector.
  - Remove the four bolts.

9. Remove the junction board from the original battery module and install it on the replacement battery module. Refer to Service Bulletin 12-048, *Junction Board Replacement (IMA Battery Module Replacement and Transfer of Junction Board)*.
